MEMORANDUM

SUBJECT: Request for Approval and Funding for a Time-Critical Removal Action at the

Little City Building Site, Ottawa, LaSalle County, Illinois

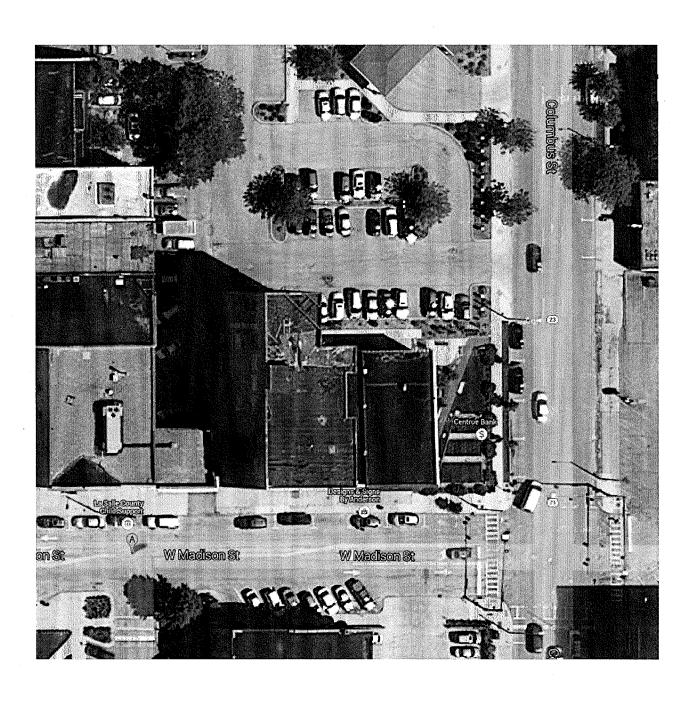
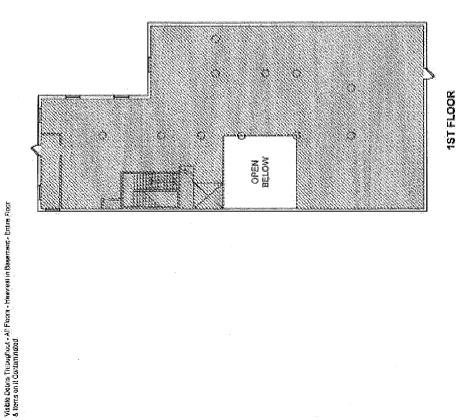
FIGURE 2

SITE LAYOUT Little City Building Site Ottawa, Illinois

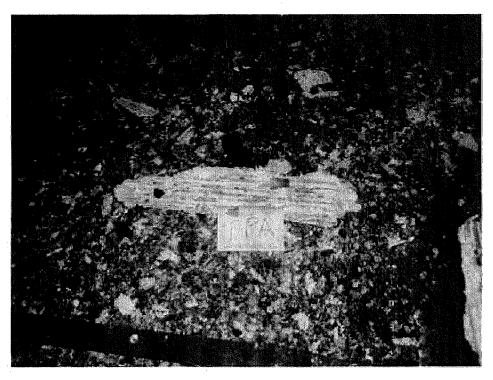
Homogeneous Area:	TPA
Material Description:	Air Cell Pipe Insulation/Debris
Location:	Basement Through 5" Floor -
	Throughout
ACM Y/N:	Yes

Comments: Visible Debris Throughout – All Floors – Heaviest in Basement Entire Floor & Items on it Contaminated.

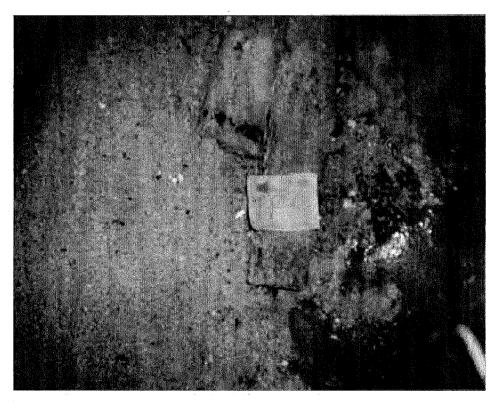
Homogeneous Area:	TPB	
Material Description:	Layered Paper Pipe	
	Insulation/Debris	
Location:	2 nd Floor –	
	In Walls & Above Ceiling	
ACM Y/N:	Yes

Comments: Debris Quantity Included with TPA.

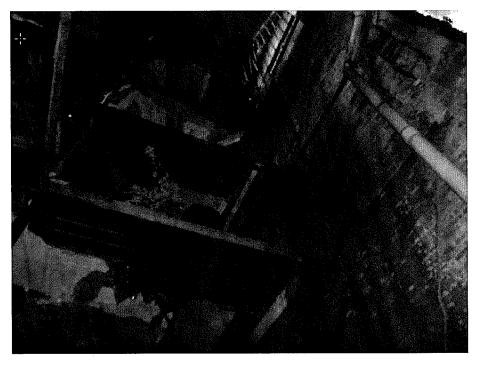
Photograph No. 9. Looking up along south side of collapsed bay.

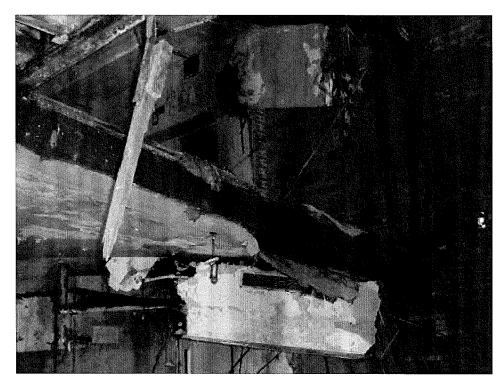
Photograph No. 10. Showing sagging floor at fourth floor level.

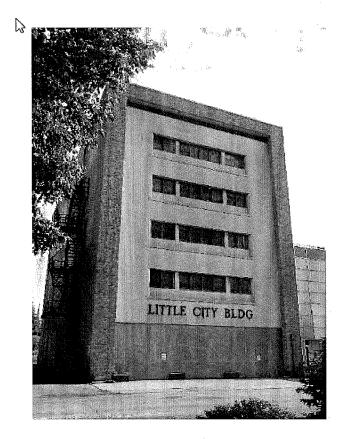
Photograph No. 1. Looking north at south elevation.

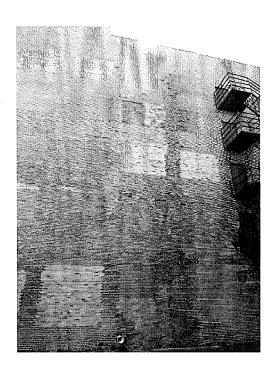
Photograph No. 2. Looking east at west elevation showing infilled windows, brick spalling, and missing bricks and mortar.

The Site comprises approximately 34,200 square feet, is a five story multi-wythe brick wall and timber floor framed structure constructed in 1902. The building's exterior west wall shows significant signs of failure due to years of water damage. Several windows are now open as past board-up measures have failed. A large area of the roof has collapsed resulting in the pancaking of floor sections on all five stories of the building. Extreme damage to all interior rooms is apparent from many years of neglect and water damage. The City of Ottawa has placed barriers along the south and west perimeters to keep pedestrians clear of the building.

The weather at the Site is average for Illinois. It is reasonable to assume that severe weather may impact the Site. Ongoing water impacts to the interior of the west wall of the building continue to deteriorate the integrity of the brick, causing the wall to bow out. Normal weather conditions, such as snow, rain and wind, will continue to be the main cause of hazardous substance release, and increase the possibility of a complete structural failure of the building.

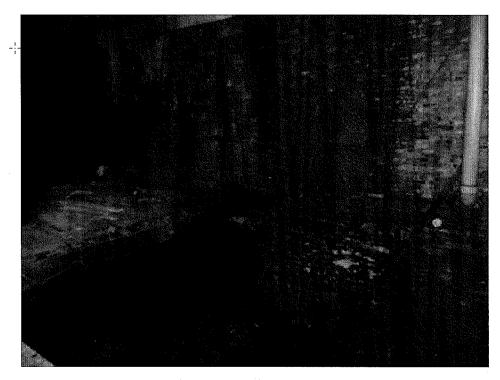
Photograph No. 8. Collapsed bay at first floor. Note sagging floor joists.

Fehr-Graham Engineering performed an investigation of the building to ascertain the existing conditions and to make recommendations for necessary shoring and stabilization to allow the asbestos to be mitigated. The collapsed floors along the west elevations have rendered the wall unsupported for its entire height. Masonry walls rely upon the lateral bracing provided by the floor systems. The bowing of the west wall observed from the exterior is consistent with unsupported masonry walls of this height. The sagging floors immediately south of the collapsed bay require shoring along with areas of the fourth and fifth floors. Repairs to all levels require access between floors, which is currently limited due to the poor condition of the stairs. Further, any vibrations that are caused by stabilization work could be detrimental to the exterior masonry walls. Fehr-Graham's professional opinion concludes that without stabilization and reroofing the building may suffer from a partial or full collapse.
